SPREAD EAGLE INN

Second Street Pike and
Almshouse Road
Richboro Village
Northampton Township
Bucks County, Pennsylvania

Notes on Site Visit of December 6, 1997

KATHRYN ANN AUERBACH Preservation Consultant

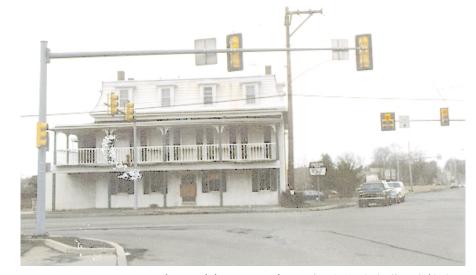
PHOTO 1

East, Front Facade and intersection (KAA:96-4) 3/96

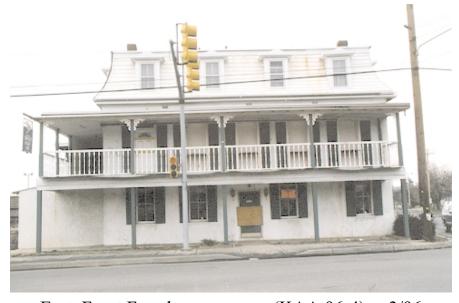
East, Front Facade

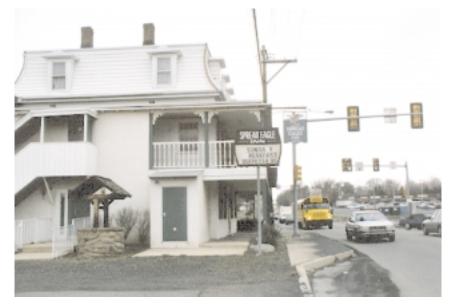
South, side facade with new basement entrance, well and side entrance (KAA:96-4) 3/96

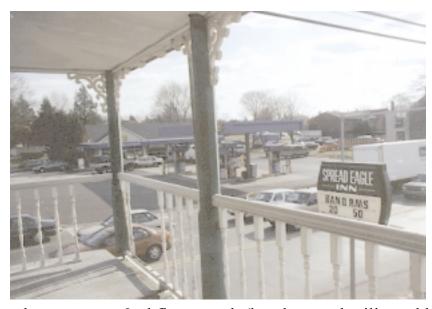
Southeast corner, 2nd floor porch (brackets and railing added late 20th century) (KAA:97-15/15) 12/6/97

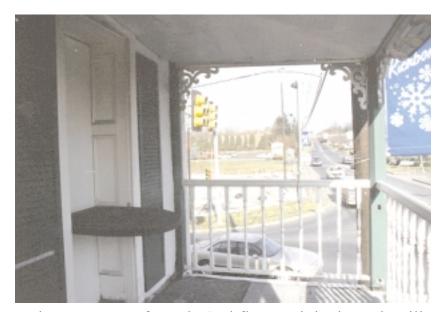
PHOTO 5

A "piazza" is mentioned in 1836 for the "front and on one end" and as porches in 1879 (*Photo 3*). The porch posts are heavy, with chamfered edges and show evidence of an earlier railing, suggesting that the structural elements of the present porches date from at least the late 19th century, if not original (*Photo 4*). Most of the window and door openings appear original although the trim and shutters are of a Victorian design. At this time the upper story windows were also enlarged to floor level to function also as doors. In the late-20th century these windows were boarded up and tables built into the recess as part of semi-outdoor dining area on the upper porch (*Photo 5*). The present railing and scroll brackets were also added (*see Blumenthal.*, p. 16 1971 photo). On the first floor front the extra door between the northern two window bays was also covered over.

Northeast corner of porch, 2nd floor, original porch railing mortise hole in post. Recessed window openings (KAA:97-15/16) 12/6/97

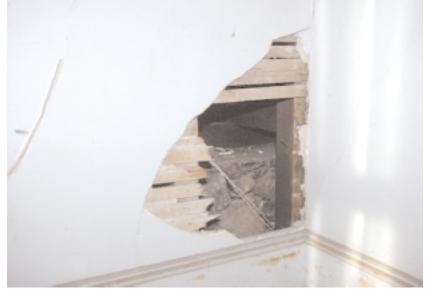
РНОТО 6

West attic wall, top of original stone wall behind plaster (KAA:97-15/10) 12/6/97

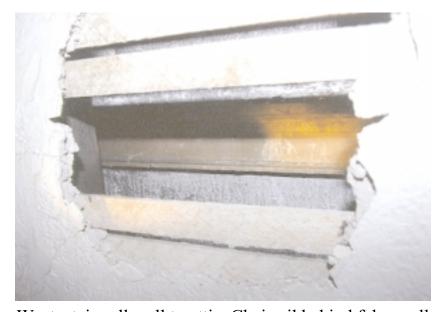
PHOTO 7

West, stairwell wall to attic. Chairrail behind false wall (KAA:97-15/12) 12/6/97

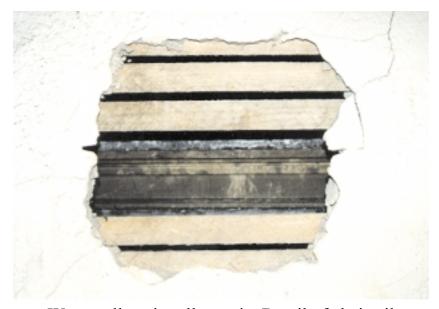
West wall, stairwell to attic. Detail of chairrail (Doug Crompton) 12/6/97

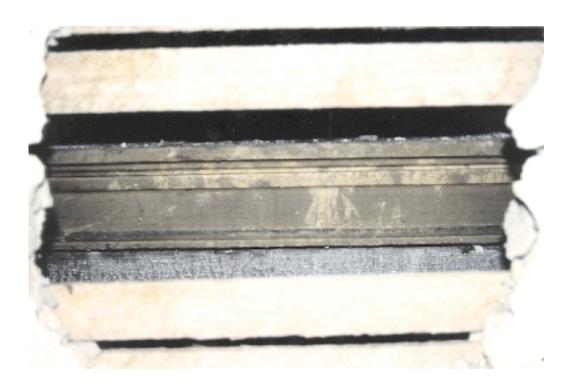
West wall, stairwell to attic. Chairrail detail (Doug Crompton 12/6/97)

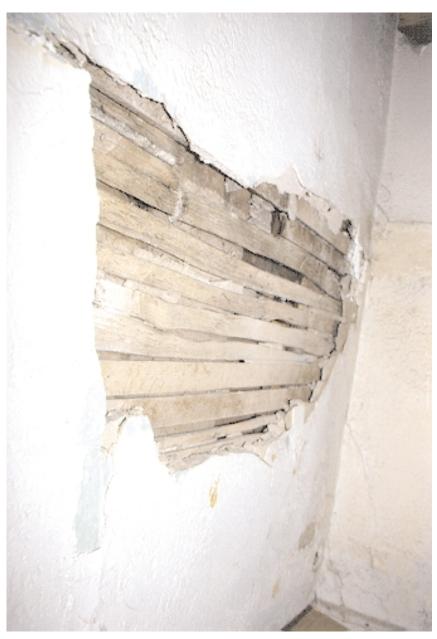
PHOTO 10

Interior partition wall, stairwell to attic. Lath detail showing both hand split and circular sawn.

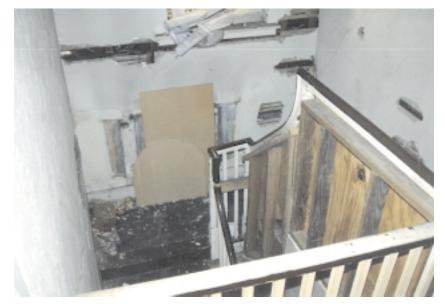
Stairwell to attic, portions of original balusters and railing. (Doug Crompton 12/6/97)

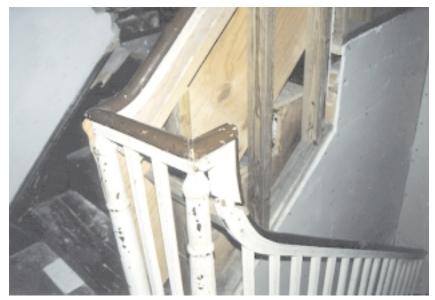
Stairwell to attic, landing detail balusters, newels and railing (Doug Crompton 12/6/97)

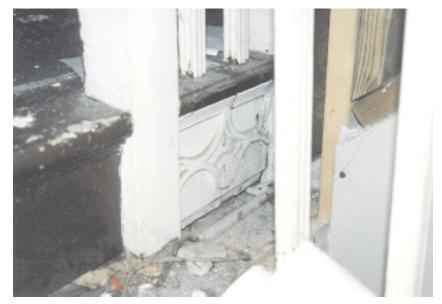
PHOTO 13

Stairwell to attic. Fretwork detail at landing (Doug Crompton 12/6/97)

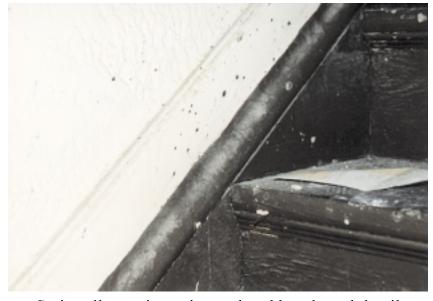
Stairwell to attic, stair tread and baseboard detail (Doug Crompton 12/6/97)

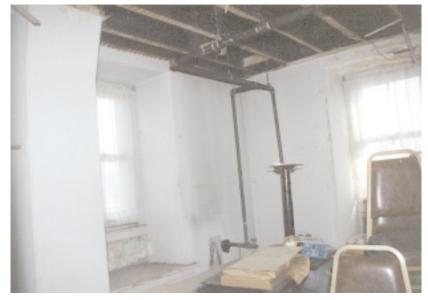
Northeast corner room attic, dormer windows (KAA:97-15/9) 12/6/97

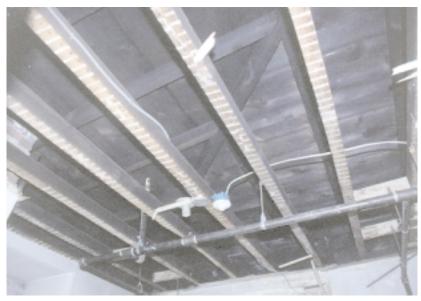
Northeast corner room attic, view of roof construction (KAA:97-15/8) 12/6/97

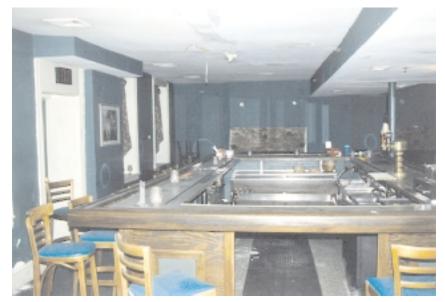
PHOTO 17

First floor, general view looking south (Doug Crompton 12/6/97)

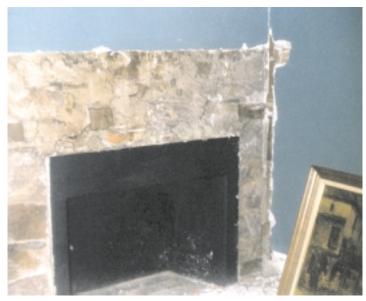
First floor, Southwest corner fireplace (Constance Gerhart 12/6/97)

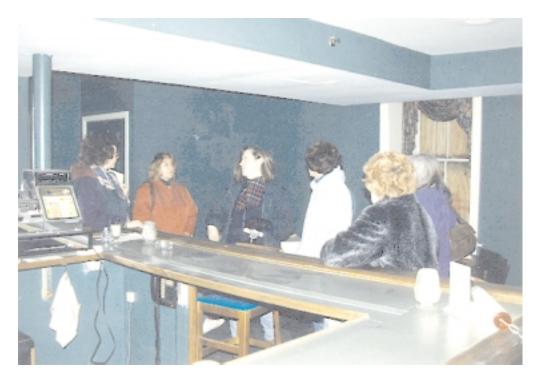
First floor to northwest corner (bathroom partition) (Doug Crompton 12/6/97)

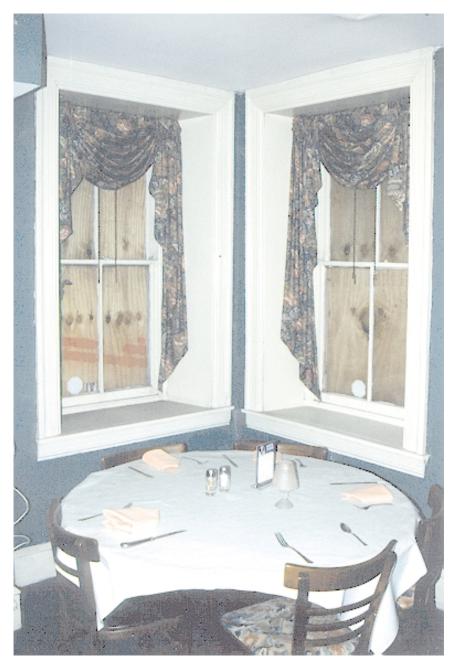
First floor view to northeast, window detail (Doug Crompton 12/6/97)

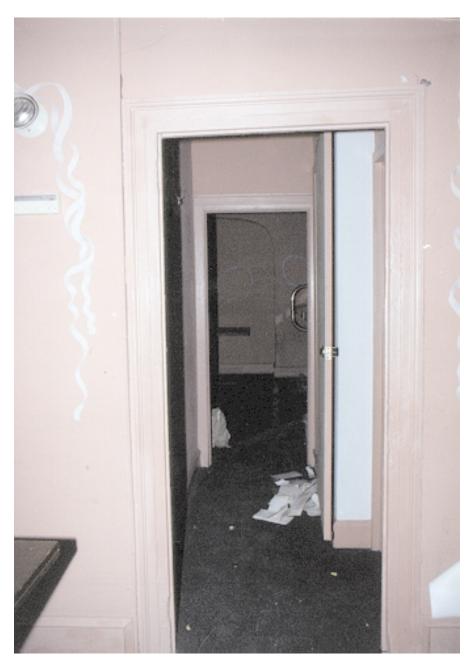
The second floor entry contains original door openings and trim leading to the large rooms to the north and south (*Photo 21*). It is possible that the short run of stairs leading up to this entry from the landing (which accesses also the large banquet room in the addition) is also original, although doors are new. The original plan is disguised by newer wall treatments and bathroom partitions, although the southern half possibly mimics its first floor counterpart. There are the chimneystacks and openings for fireplaces like those below (*Photo 24*).

Second floor view from north room through entry hall (original door trim) (KAA:97-15/18) 12/6/97

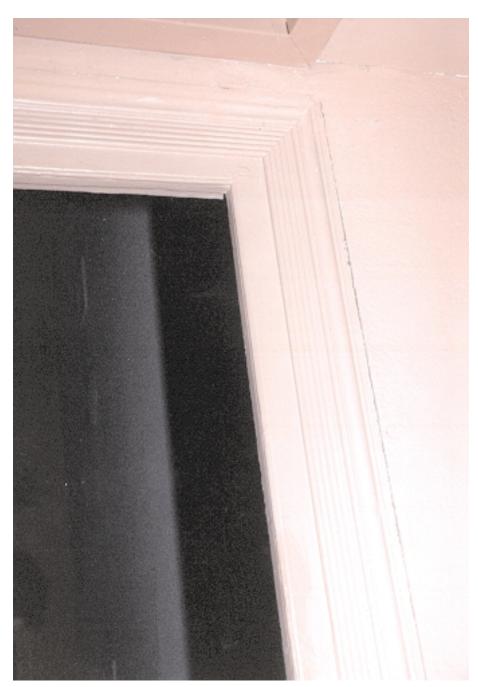
PHOTO 22

Second floor original door trim in entry hall (KAA:97-15/19) 12/6/97

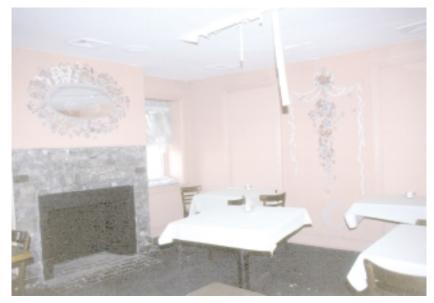
Second floor general view to northeast corner (note fireplace and window openings) (KAA:97-15/17) 12/6/97

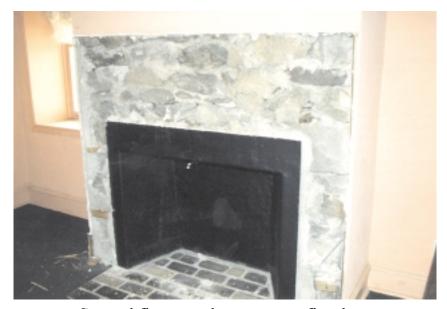
Second floor southeast corner fireplace (Doug Crompton 12/6/97)

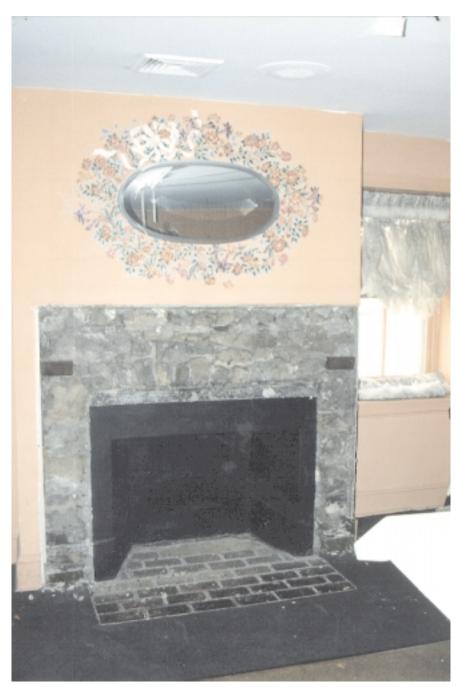
North wall second floor fireplace (Doug Crompton 12/6/97)

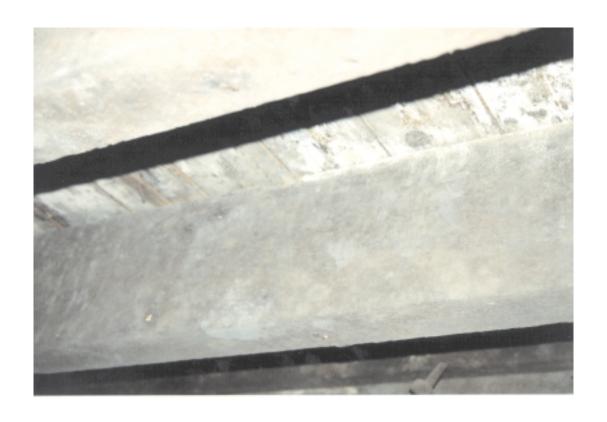
PHOTO 26

The basement was inspected for its basic features and relationship with the upper stories of the hotel. Present, and apparently original exterior entrance was gained from exterior steps (formerly a bulkhead, now an enclosed full size doorway) leading down on the south side in the SE corner of the cellar (*Photo 3, 27*). The interior wall finishes throughout the basement were recently resurfaced with a cement stucco in some cases disguising earlier features and clues, including cellar windows along the front. The main basement seems to uniformly sit underneath the 42 by 30 foot original hotel and is divided into two sections laterally by a stonewall which serves as the support for the two spans of floor joists running from front to back. The floor joists are milled, most with up-and-down saw marks, although some, in the northeast corner in particular, appear to have pit saw marks (although finer than the usual rough cut appearance) (*Photo 26*).

Basement floor joist detail (Doug Crompton 12/6/97)

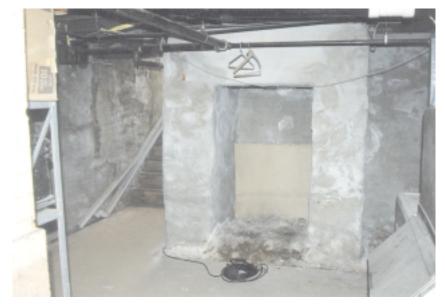
PHOTO 27

Fireplace supports evident correspond to the fireplaces existing today on the first floor, namely the two parlor sized ones on the south end wall. These supports are two stone piers, which extend out to support the sidewalls of the chimneystack with heavy timbers set across the top to support the hearth area (Photos 27, 28). On the north end of the building evidence is less straightforward, if even non-existent. In the northeast parlor area there is no indication that there ever was a fireplace or support, corresponding to the lack of one on the first floor and suggesting a separate corbeled support for the fireplace on the second floor. In the northwest corner of the basement is the modern heating furnace, which uses a chimneystack that runs up along the rear west wall. In the small area between the flue and the actual NW corner is a small area of floor higher than the present cement floor, which has the original stone surface intact (Photo 29). In the wall area directly above in this corner is a boarded space, which appears to have been a window or opening. To the left of the furnace flue is a door opening into a small cellar area (approximately 9' x 141). Along the north wall in this corner area but next to the middle partition wall is another set of exterior cellar bulkhead steps. Finish work around the opening suggests that it may have been broken through at a later date. The interior stair access to the basement is a straight run staircase against the rear west wall directly beneath the present staircase from the first to second floors. Again, due to surface refinishing of the walls and extensive piping and wiring and other shelving built in for the restaurant, any scarring from an earlier staircase has been obscured. Beneath the present kitchen (against the rear west wall) and extending towards the tiny alcove cellar is a crawl space with an intermediate stonewall to support the circular sawn floor joists.

Basement fireplace support, south wall near southeast corner (note entrance to left) (Doug Crompton 12/6/97)

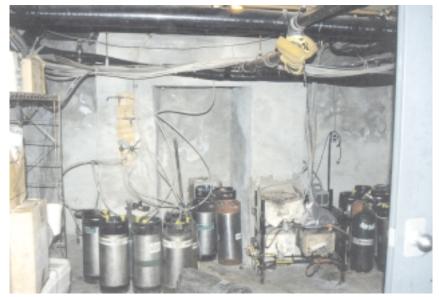
Basement fireplace support south wall near southwest corner (Doug Crompton 12/6/97)

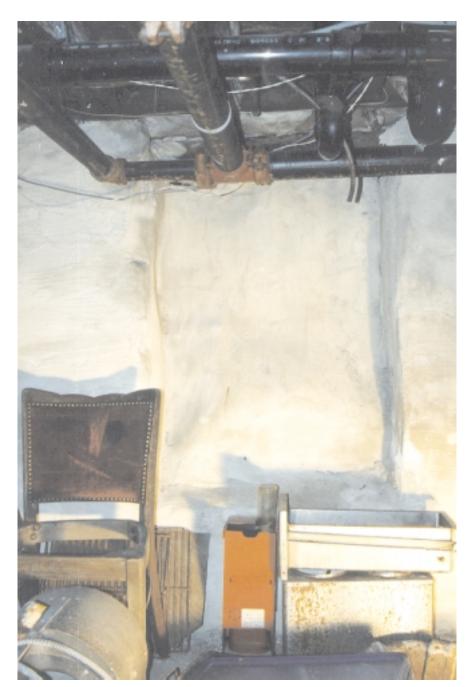
Northwest corner of basement, furnace chimney, original stone floor, boarded window? (Doug Crompton 12/6/97)

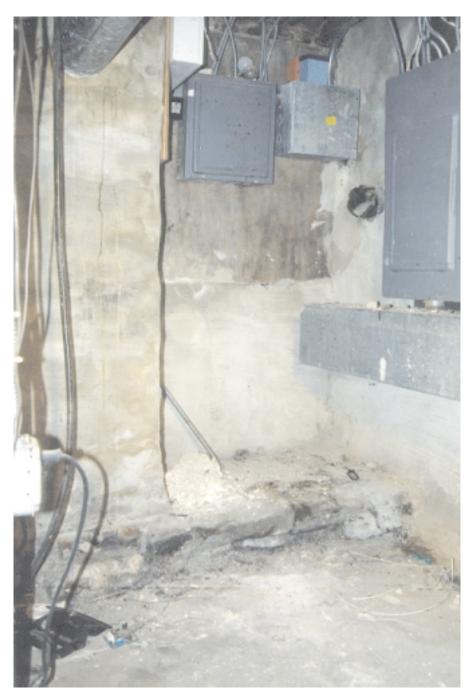
If this corner contained a large fireplace since removed, the chimneystack appears also to have been removed. Curiously, this is the corner with the bathroom on the first floor, which may conceal evidence of scarring from the removal. The blocked "window" in the basement wall (*Photo 30*) could be an opening, which was part of a bake oven opening; the doorway could have been cut through later or may have been direct access to the outside, in an exposed basement area. If possible, this area should be further inspected before the hotel is moved.

Basement alcove, view back to northwest corner of regular basement, closed window? (Doug Crompton 12/6/97)

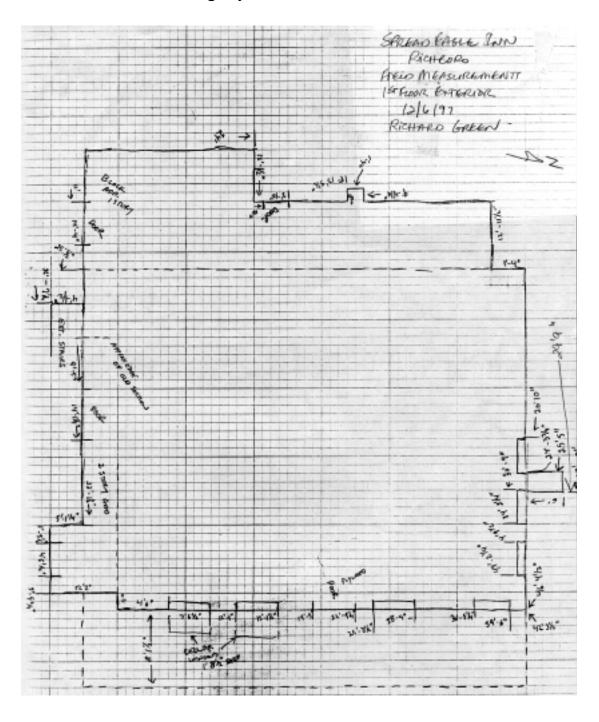
Outside Building dimensions, Spread Eagle Inn, Richboro, Bucks County, PA (original front section)
